EXPLOSIVE EVENT IN MON-3 OXIDIZER SYSTEM RESULTING FROM PRESSURE TRANSDUCER FAILURE*

Michael Reynolds and John Anderson
White Sands Test Facility/Honeywell Technical Solutions Inc.
Las Cruces, NM

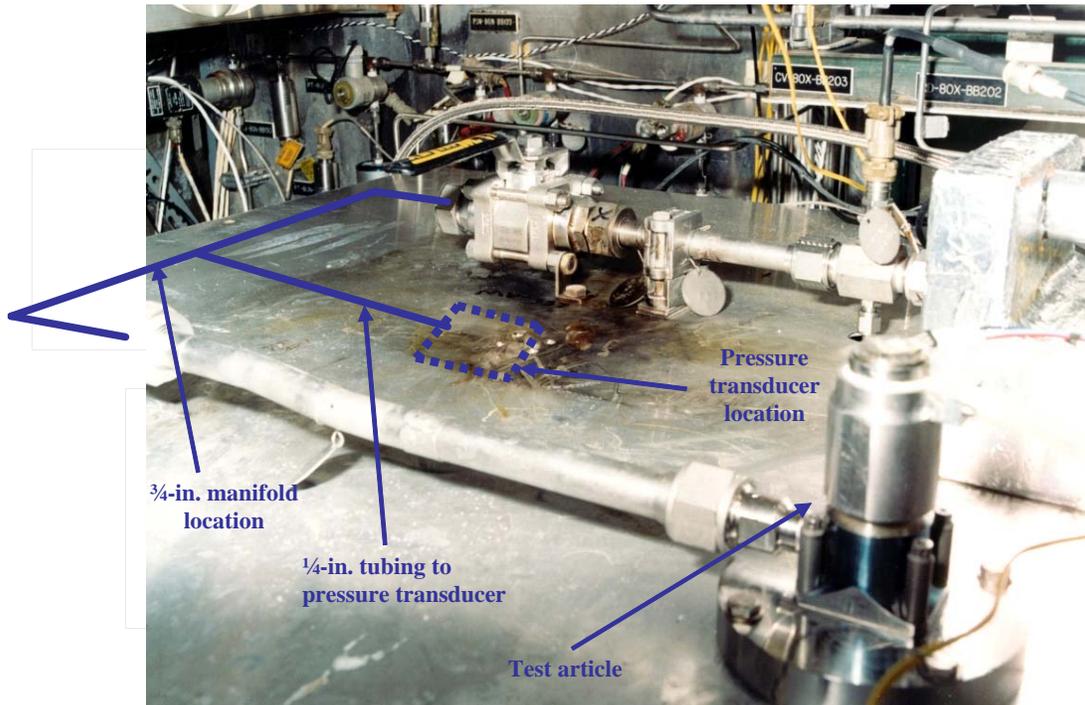
During the inspection, it was immediately obvious a pressure transducer on the test article inlet line failed catastrophically, releasing liquid NTO into the test cell. Figure 1 shows the area of the pressure transducer failure and the approximate previous location of the manifold and pressure transducer. The test team recovered the inlet port and body of the pressure transducer and approximately three-quarters of the diaphragm. The cause of the failure was unknown at this point. An investigation team was assembled to review the situation and determine the cause of the failure and how to avoid similar problems in the future.

Figure 1: Location of Failed Pressure Transducer

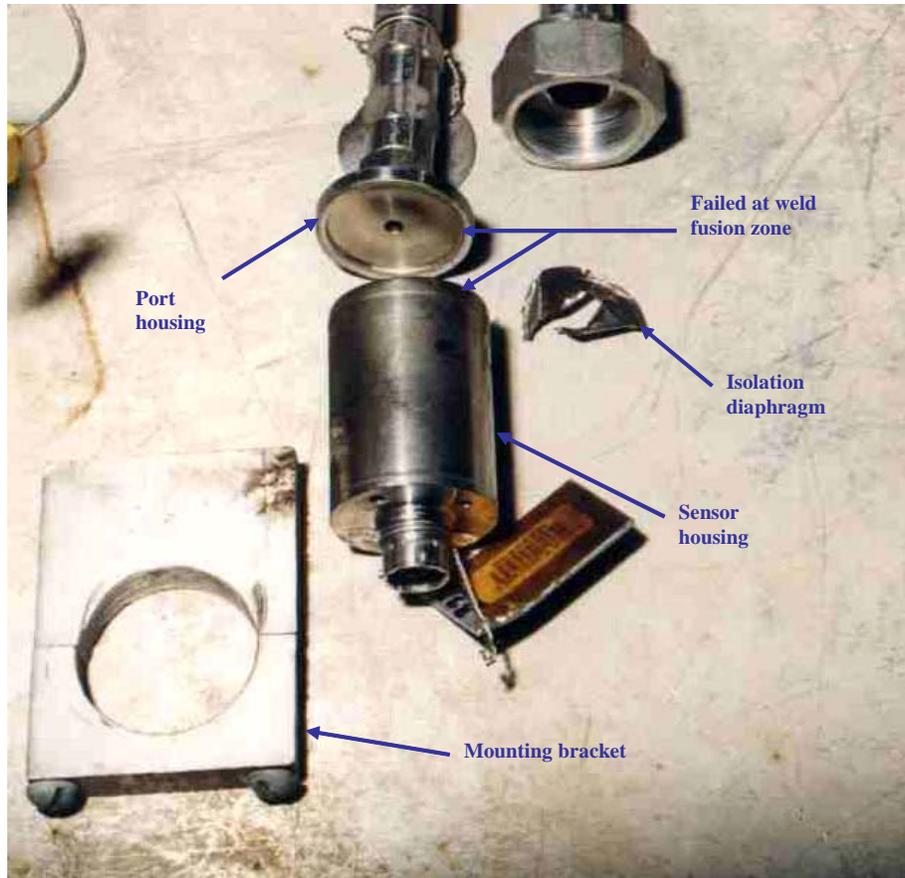
The pressure transducer failed at the welded connection between the transducer body and inlet housing (Figure 2). The weld appears to be an electron beam weld (EBW) butt weld configuration. Failure of this weld is from longitudinal stress in the weld fusion zone. The pressure to fail this welded connection was calculated to be 12,700 psi. The $\frac{1}{4}$ x 0.035-in. wall 300-series stainless steel tubing connecting the pressure transducer to the $\frac{3}{4}$ x 0.035-in. wall 300-series stainless steel manifold tubing failed close to the $\frac{3}{4}$ -in. tubing. Although the $\frac{1}{4}$ -in. tubing was significantly deformed, the damage primarily appeared to be from thrust generated when the pressure transducer failed. Based on measuring the outside diameter in several locations, the $\frac{3}{4}$ -in. tubing showed no sign of yielding due to pressure. This indicates the system pressure did not exceed the calculated 3,400 psi required to yield this tubing. A small, central area of the failed diaphragm, which matches the inlet port flow passage diameter, was bulged and ruptured (Figure 3). The calculated pressure to burst the diaphragm when supported at the port diameter is \sim 4,000 psi. Based on these observations, the failure appears to be the result of extremely rapid over-pressurization inside the pressure transducer and behind the isolation diaphragm that first exceeded the \sim 4000-psi diaphragm burst pressure. Flow through the 0.157-in. port flow diameter was inadequate to relieve the over-pressure, thus enabling the pressure to reach the \sim 12,700-psi housing burst pressure. After burst, sufficient thrust was achieved to deform and then fail the $\frac{1}{4}$ -in. tubing connected to the pressure transducer. The sensor location of the pressure transducer is shown in Figure 4. Note the oily residue seen in this photo.

Figure 2: Failed Druck® PDCR 130/W/C Pressure Transducer

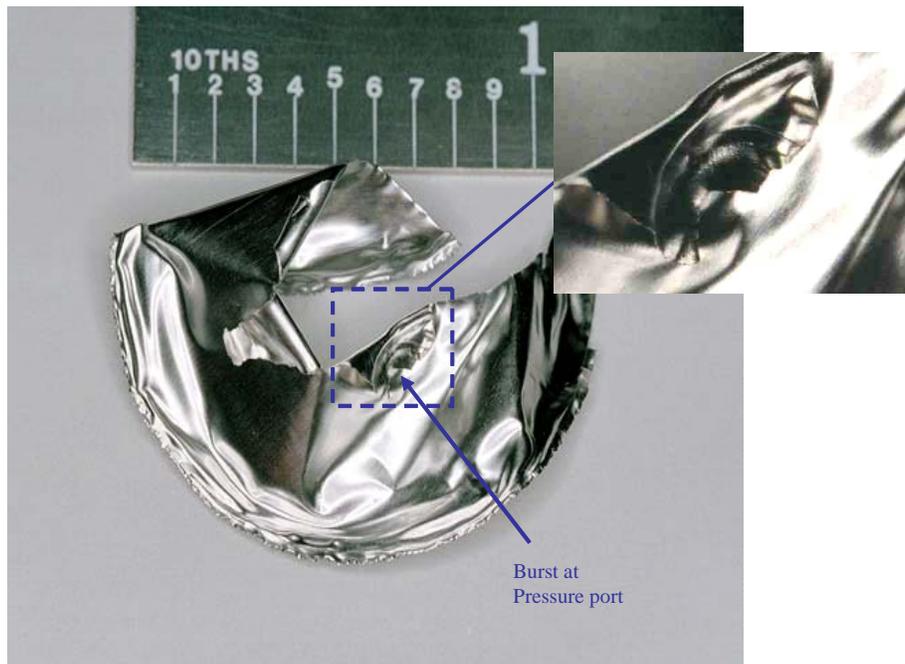
Figure 3: Failed Isolation Diaphragm

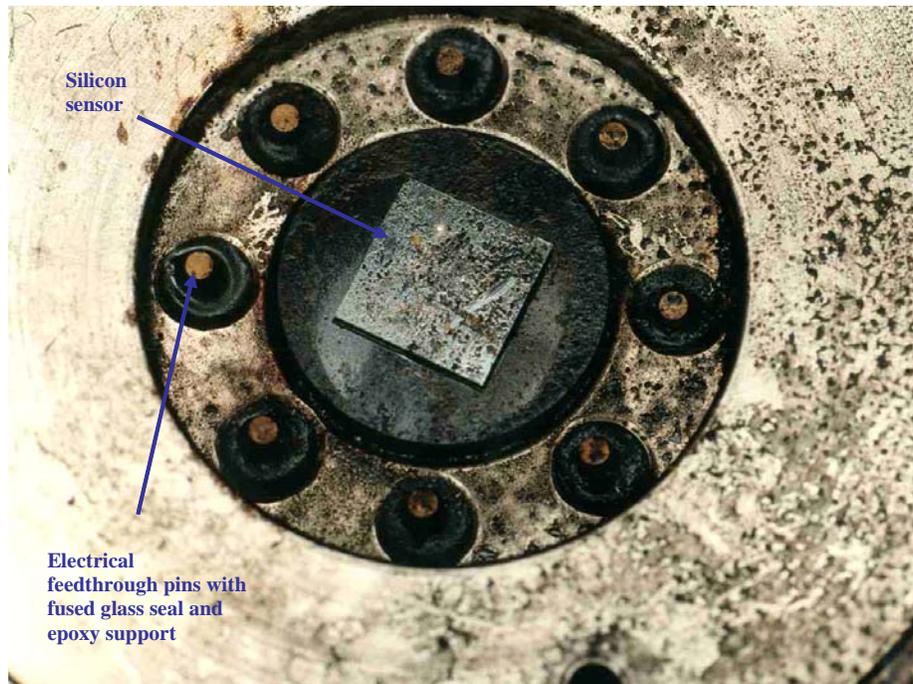
Figure 4: Failed Pressure Transducer Sensor

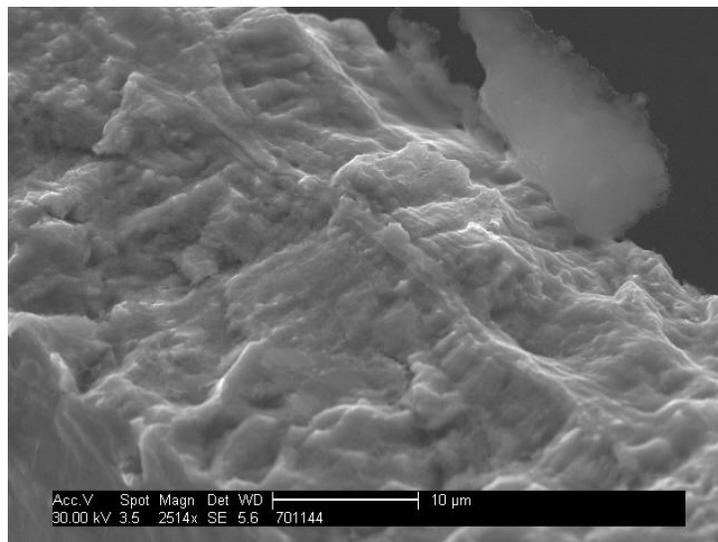
The pressure port housing and the recovered section of the isolation diaphragm were submitted for analysis of the fracture surfaces. The diaphragm exhibited evidence of fatigue fractures, as shown in Figure 5, propagating from multiple initiation sites. Transgranular, partial penetration, secondary fractures were also observed on the diaphragm surface adjacent to and aligned with the through-thickness circumferential fracture, as shown in Figure 6.

Figure 5. Scanning Electron Photomicrograph of Crack Arrest Marks and Fatigue Striations Observed On Circumferential Diaphragm Fracture

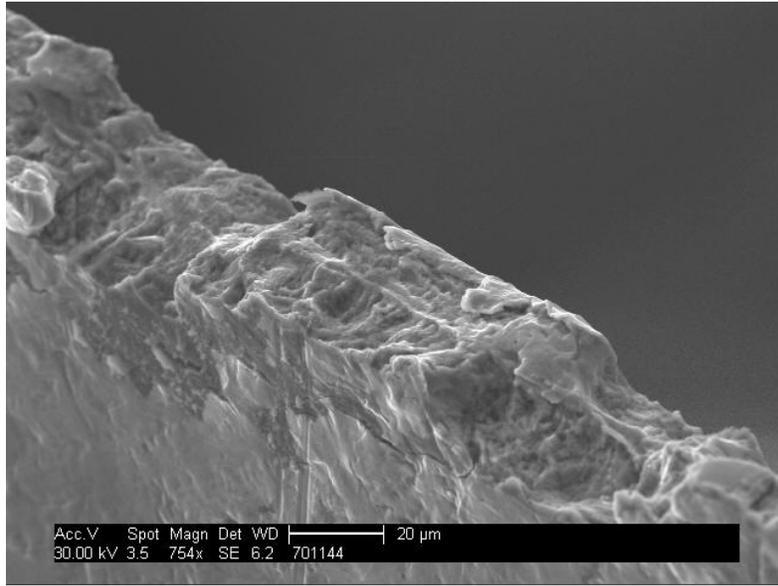
Figure 6. Scanning Electron Photomicrograph of Crack Arrest Marks Observed On Circumferential Diaphragm Fracture
(Note the transgranular, partial penetration, secondary fractures on the diaphragm surface adjacent to and aligned with the through-thickness circumferential fracture.)

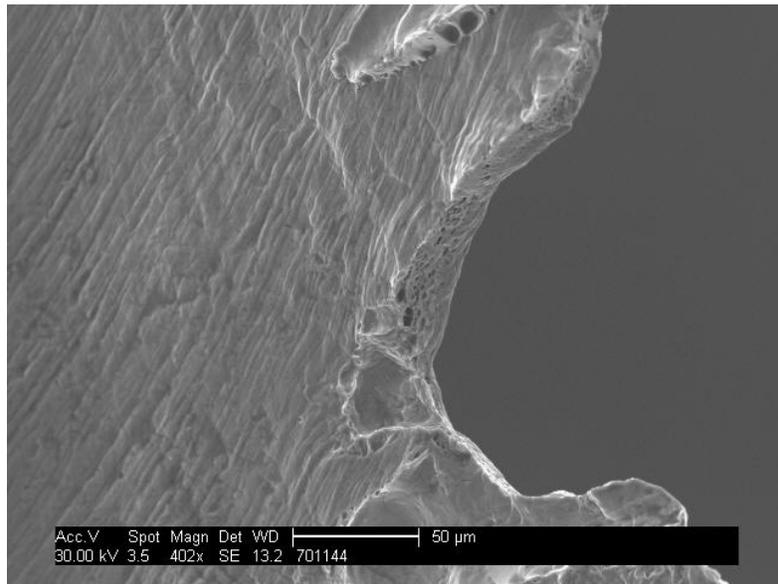
The remainder of the diaphragm fracture surface was described as ductile overload rupture, as shown in Figure 7. No evidence was found that indicated the fatigue fractures were initiated by environmental degradation or a metallurgical discontinuity. X-ray microanalysis indicated the isolation diaphragm alloy was a molybdenum-bearing austenitic stainless steel, consistent with the manufacturer's specification stating 316 stainless steel. The results of microstructural analysis and microhardness testing indicated that the isolation diaphragm material is in the annealed condition.

Figure 7: Scanning Electron Photomicrograph of Elongated Dimples Observed on Circumferential Diaphragm Fracture at EBW Root, Indicative of Ductile Behavior

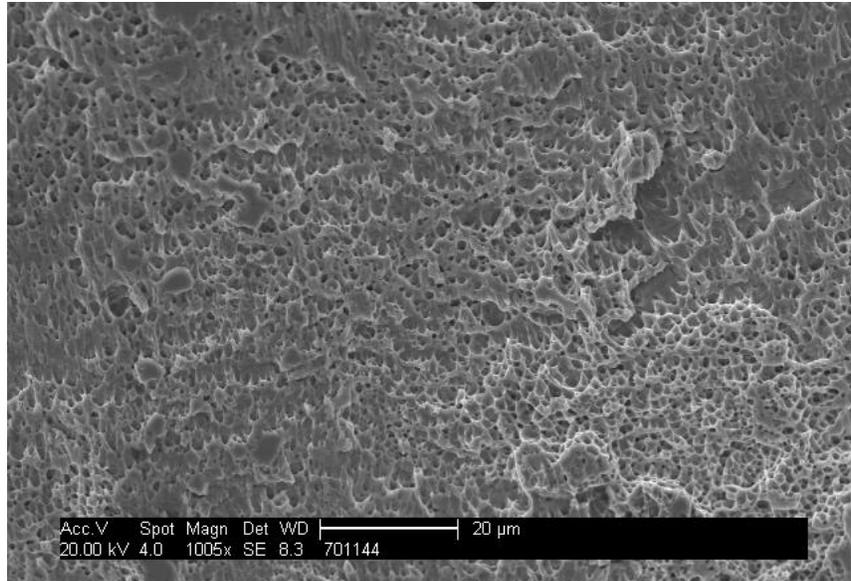
The transducer housing fracture, which occurred at the weld fusion zone, was found to be a ductile overload failure resulting from a single load application, based on analysis of the pressure port end fracture surface, as shown in Figure 8.

Figure 8: Scanning Electron Photomicrograph Showing Elongated Dimples on Circumferential Pressure Port End Fracture Surface, Indicative of Ductile-Type Overload Rupture
